DOC NO. 150-040051

## APPLICATION NOTE WAN-002

# RESOLVING RADIO INTERFERENCE PROBLEMS

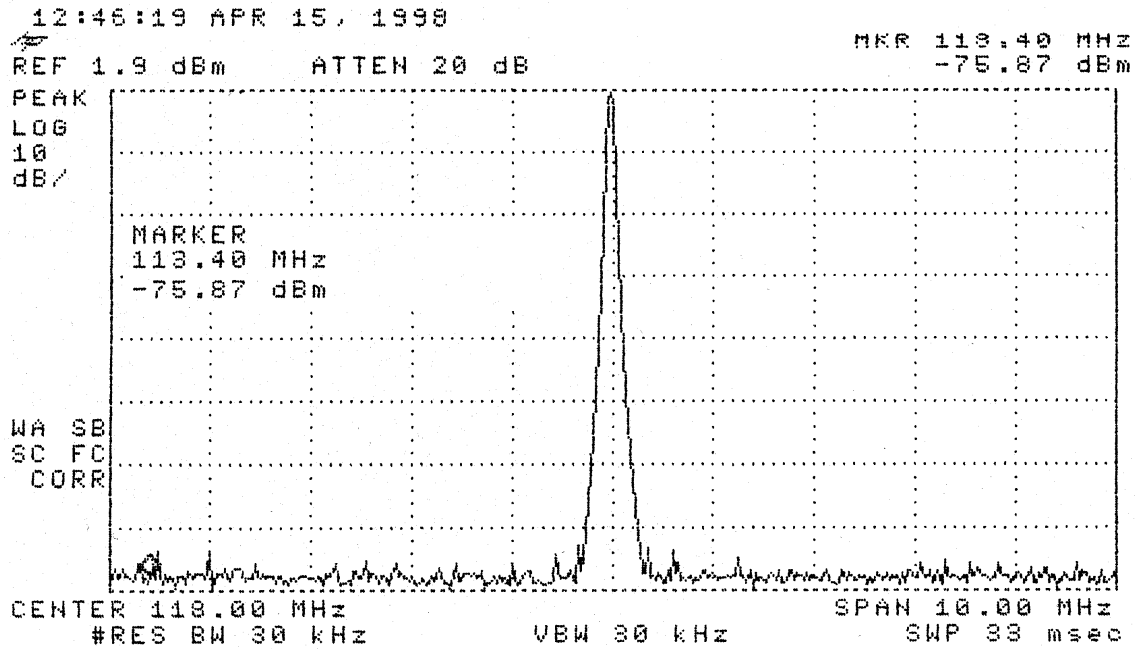
The following two spectrographs are typical spurious output levels of a RT-5000 terminated into a 50 Ohm load. These measurements were made with a HP 8594 spectrum analyzer. It is important to note that the input-related spurious response of the analyzer is rated at  $<-65$  dBc. The spurious signal level was measured below  $-75$  dBc but may be much lower since  $-75$  dBc is 10 dB lower than the analyzer's specified performance.

Figure 1. Spectral output of the RT-5000 transmitting at 118 MHz AM with marker set @ 113.4 MHz, 50 Ohm load.

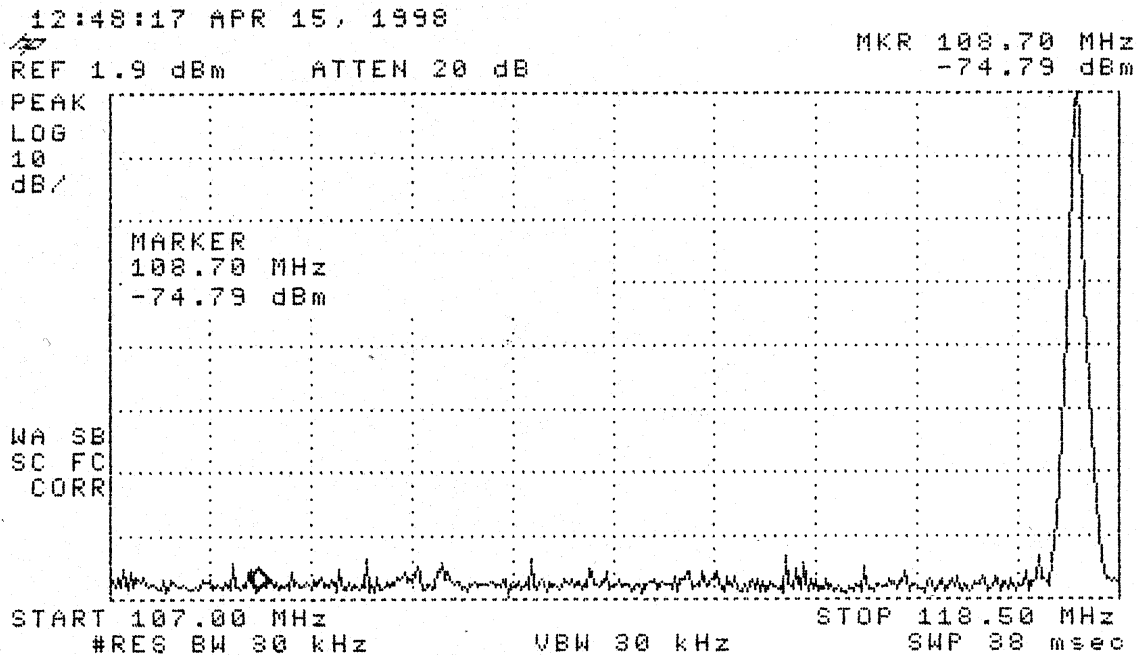
Figure 2. Sideband spectral output of the RT-5000 transmitting on 118 MHz, 50 Ohm load.
